MARYLAND HISTORICAL TRUST WORKSHEET

NOMINATION FORM for the NATIONAL REGISTER OF HISTORIC PLACES, NATIONAL PARKS SERVICE

AA-226

1. NAME				
COMMON:				
Margaret's Fields		Mayo-McCarter House		
AND/OR HISTORIC:				
2. LOCATION				
STREET AND NUMBER:				
Entrance on east side of Shoreham Beach Road, opposite Cedar Lane,				
CITY OR TOWN:				
Shoreham Beach near Mayo Beach				
STATE:		COUNTY:		
Maryland		Anne Arundel

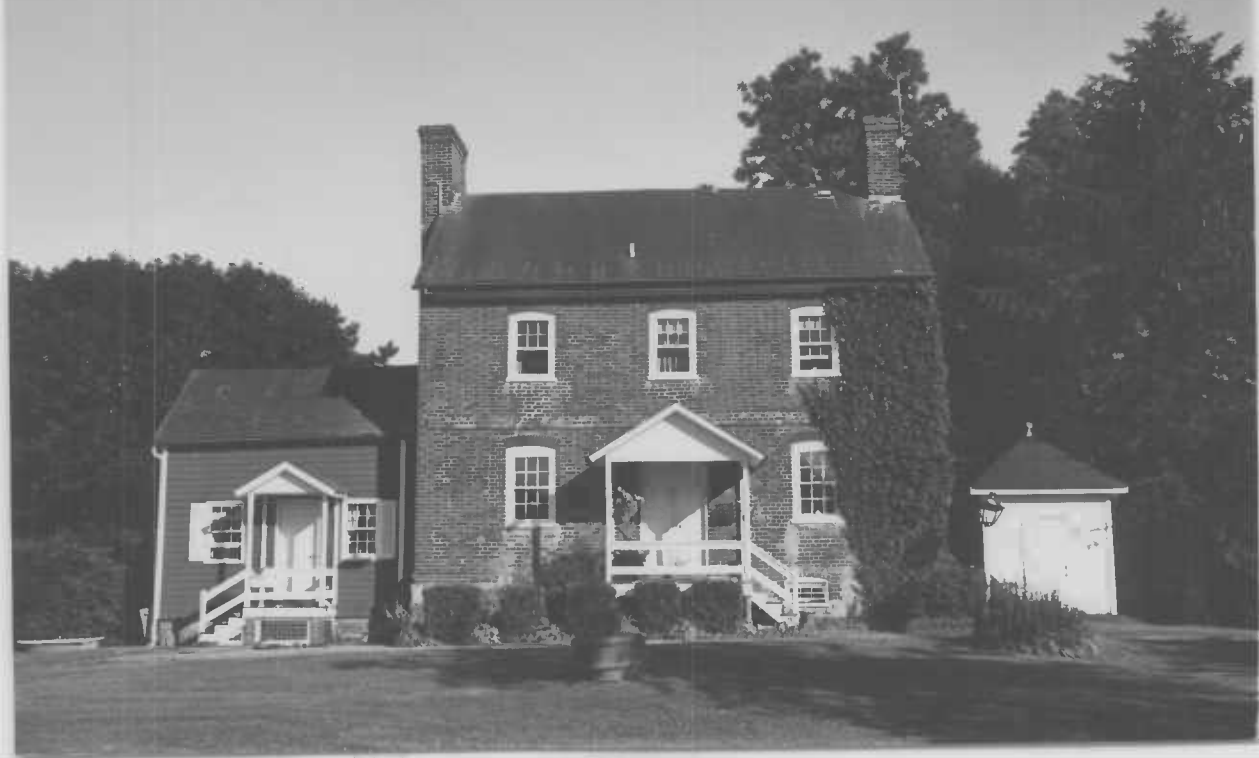
Carlson residence
Margaret's Fields
west elevation

The west elevation is identical to the east elevation except that the center window has always been the same size as the others. The ground slopes down slightly toward the west, and as a result more of the foundation is exposed. The original entrance to the basement is located on this side at the north end of the building. Patches in the brick-work around the door leading to the first floor show that the porch dimensions have been changed. The present porch is identical to that on the east elevation.

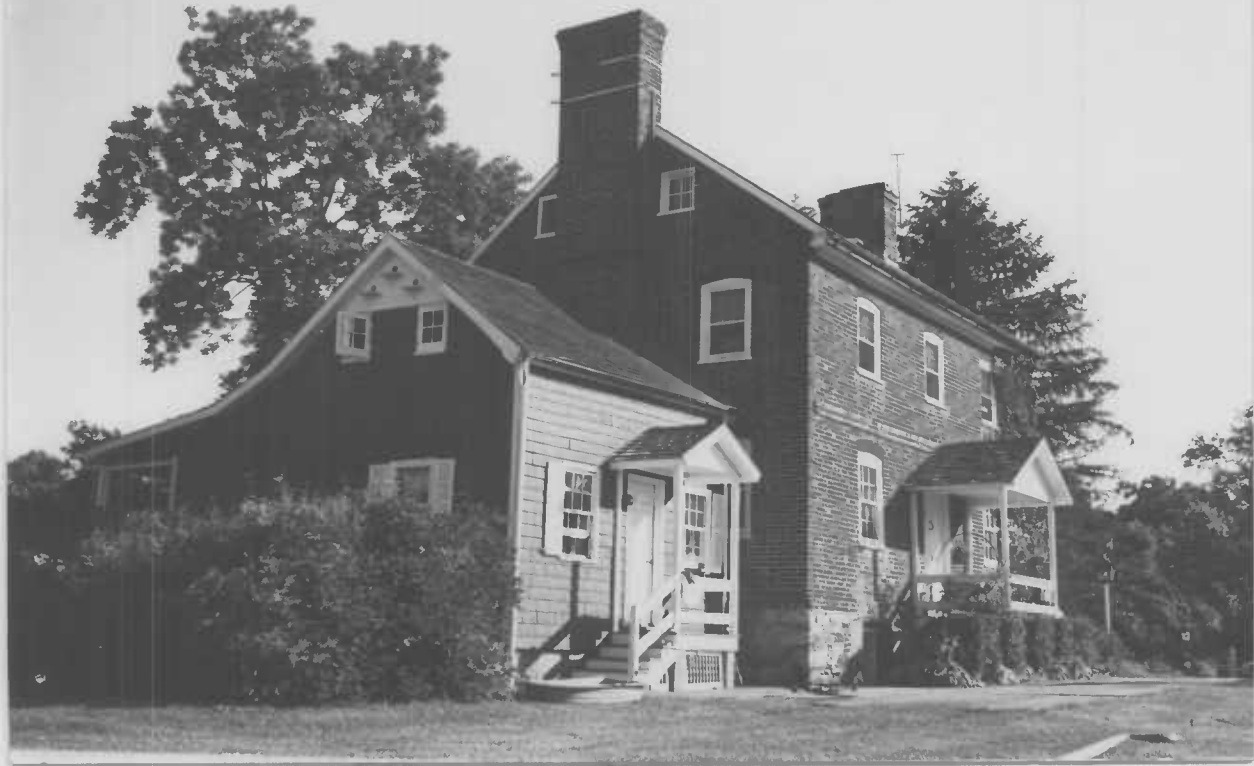
Carlson residence
Margaret's Fields
Kitchen and house
N.W. corner

The south (end) wall of the house has no openings and the chimney stack is on the inside so that the outside of the wall is smooth. On the north end, however, the chimney is completely outside the wall and it may have been built with a fireplace opening on its north side to serve a kitchen or other addition. There is one window on the west side of each floor, and small square attic window on either side of the chimney. The first floor window has an old frame and sash and old glass. It is the only such window in the house.

The frame kitchen adjoins the north wall of the house. It consists of one room with a loft above and a shed addition on the east side. There is a dove-cote in the peak of the main roof. The exterior of the kitchen has been covered with wood shingle and the interior has been completely modernized so that it would be difficult to determine the age of the structure.

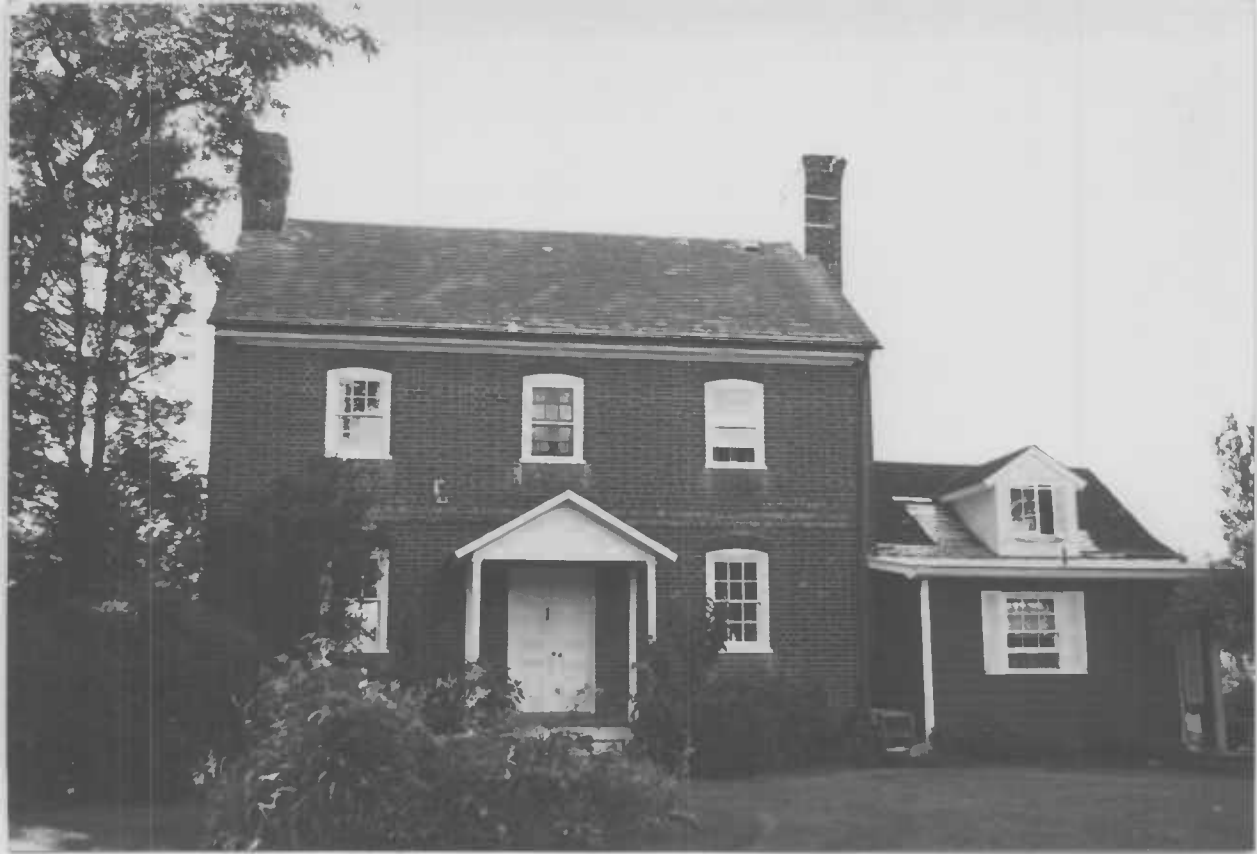
Carlson residence
Margaret's Fields
east elevation

The east (front) elevation has three evenly spaced openings on each floor. The front entrance is in the center under a simple A-roofed porch of recent date. The double doors are set into the wall without side or transom lights.

The center window on the second floor has been filled in to make it the same size as the others. The arrangement of closers in the brickwork indicates that the original opening was a door, the sill of which rested on the top of the belt course. There are no marks in the brick work to indicate the appearance of the original porch.

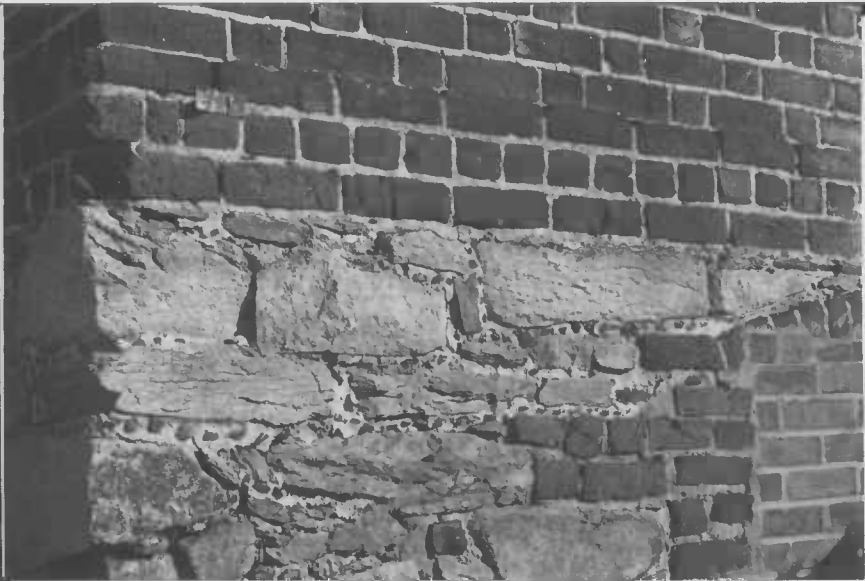
Carlson residence
Margaret's Field's
foundation detail
N. W. corner

The house stands on a high, stone foundation. The rough stonework has garreted mortar joints. Three brick courses rest on top of the stone wall and form the top of the watertable. All four walls of the house are laid in Flemish bond. The east and west walls have a three brick high, all header, belt course between the first and second floors. The window openings all have segmental arches made of rubbed brick stretchers. Almost all of the window frames and sashes have been replaced but the originals were probably 9/6 on the first floor and 6/6 on the second.
